Fw 190D

Walk Around Number 10
squadron/signal publications

By E. Brown Ryle and Malcolm Laing

Focke-Wulf Fw 190D-9

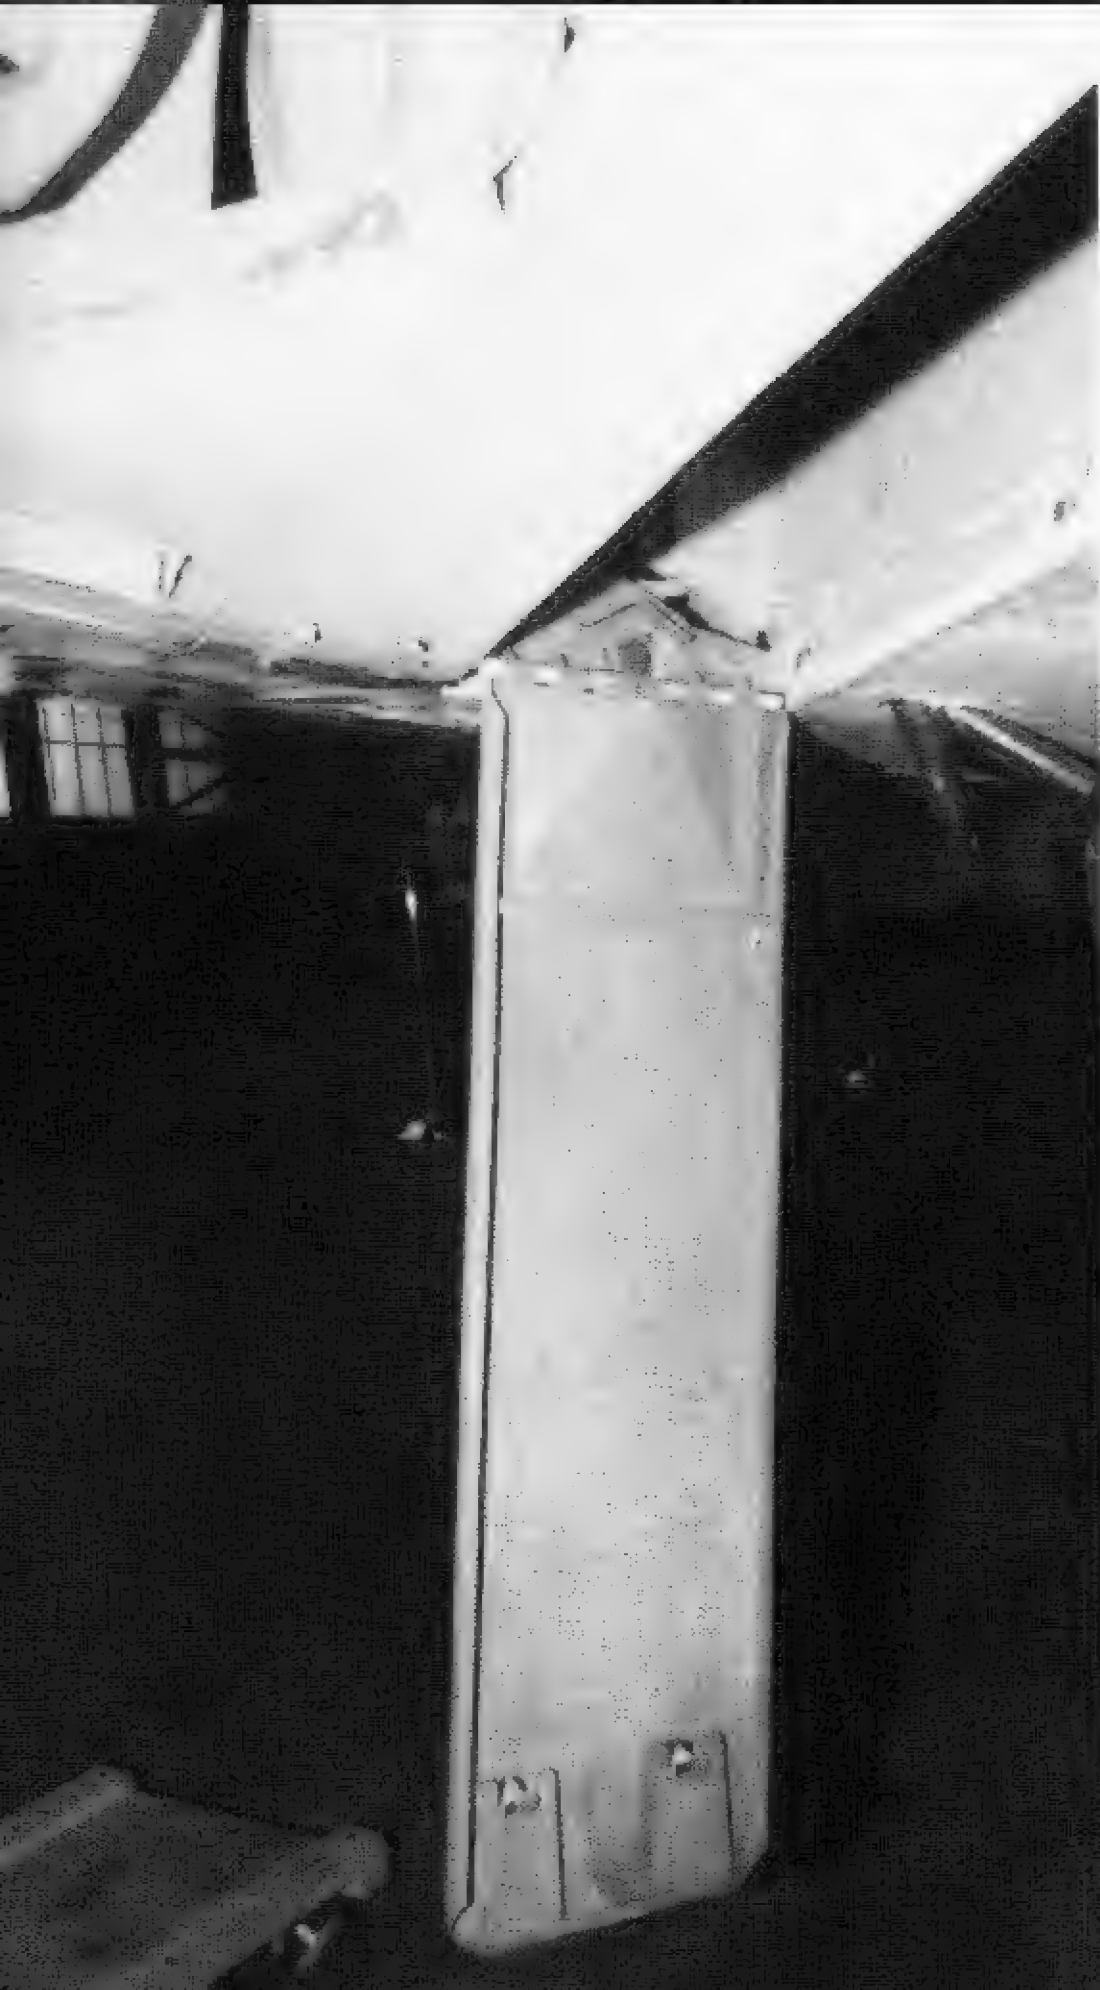
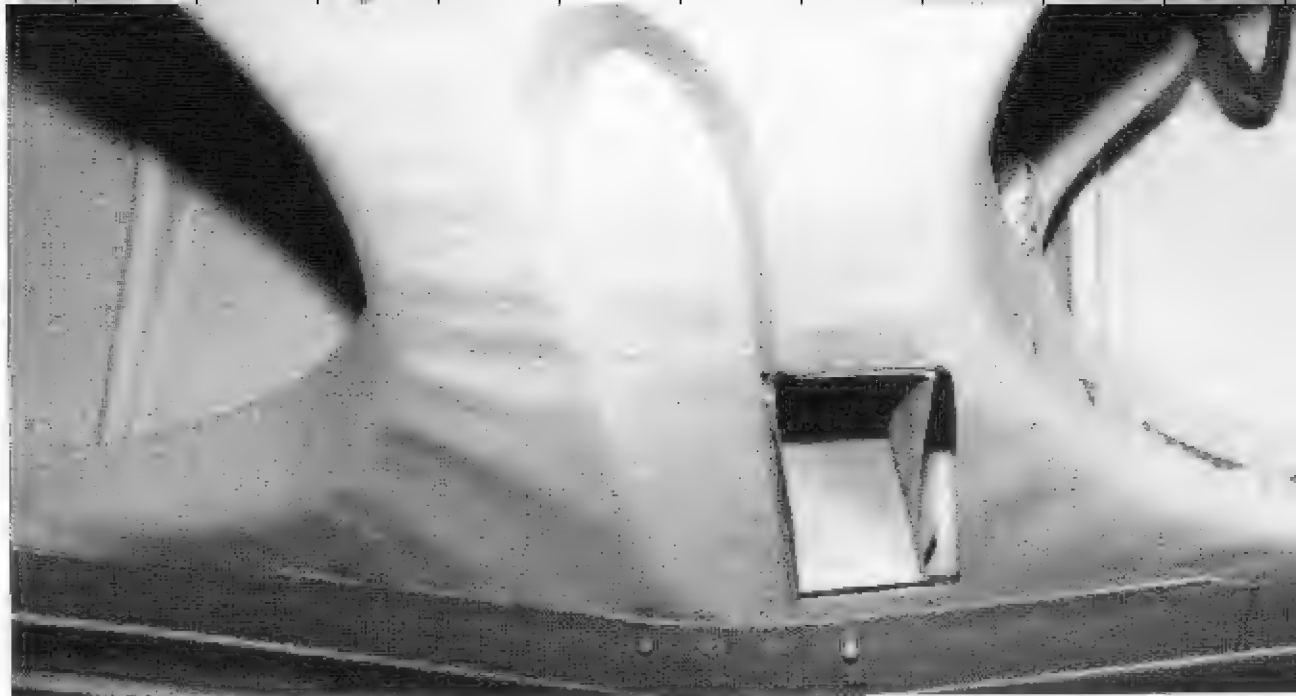
(Above) The ejection port for an engine mounted cannon is just to the port side of centerline. The indentation on the centerline is an aerodynamic feature designed to accommodate the forward portion of the or ETC 504 drop tank/bomb rack. This center panel is a single stamped part and the wrinkles from the stamping can be seen. (Author: Ryle)

(Left and below) On the wing bottom, just aft of the wheel well is one of the two access panels for the wing root 20mm cannon ammo trays. Two 250 round ammo trays were loaded and unloaded through these panels which hinged at the center. The fuel tank vents are located directly behind these doors. (J. Bishop)

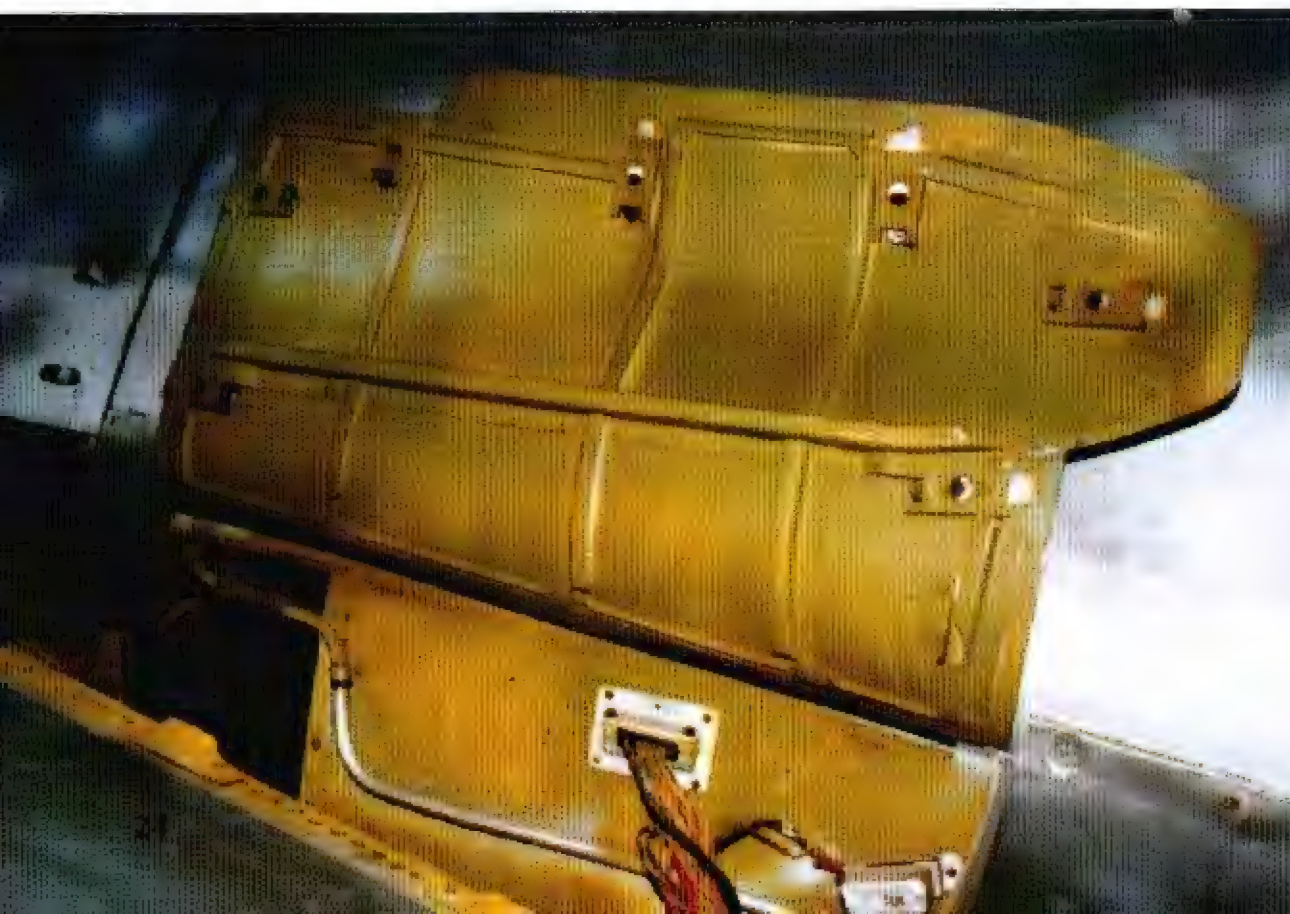
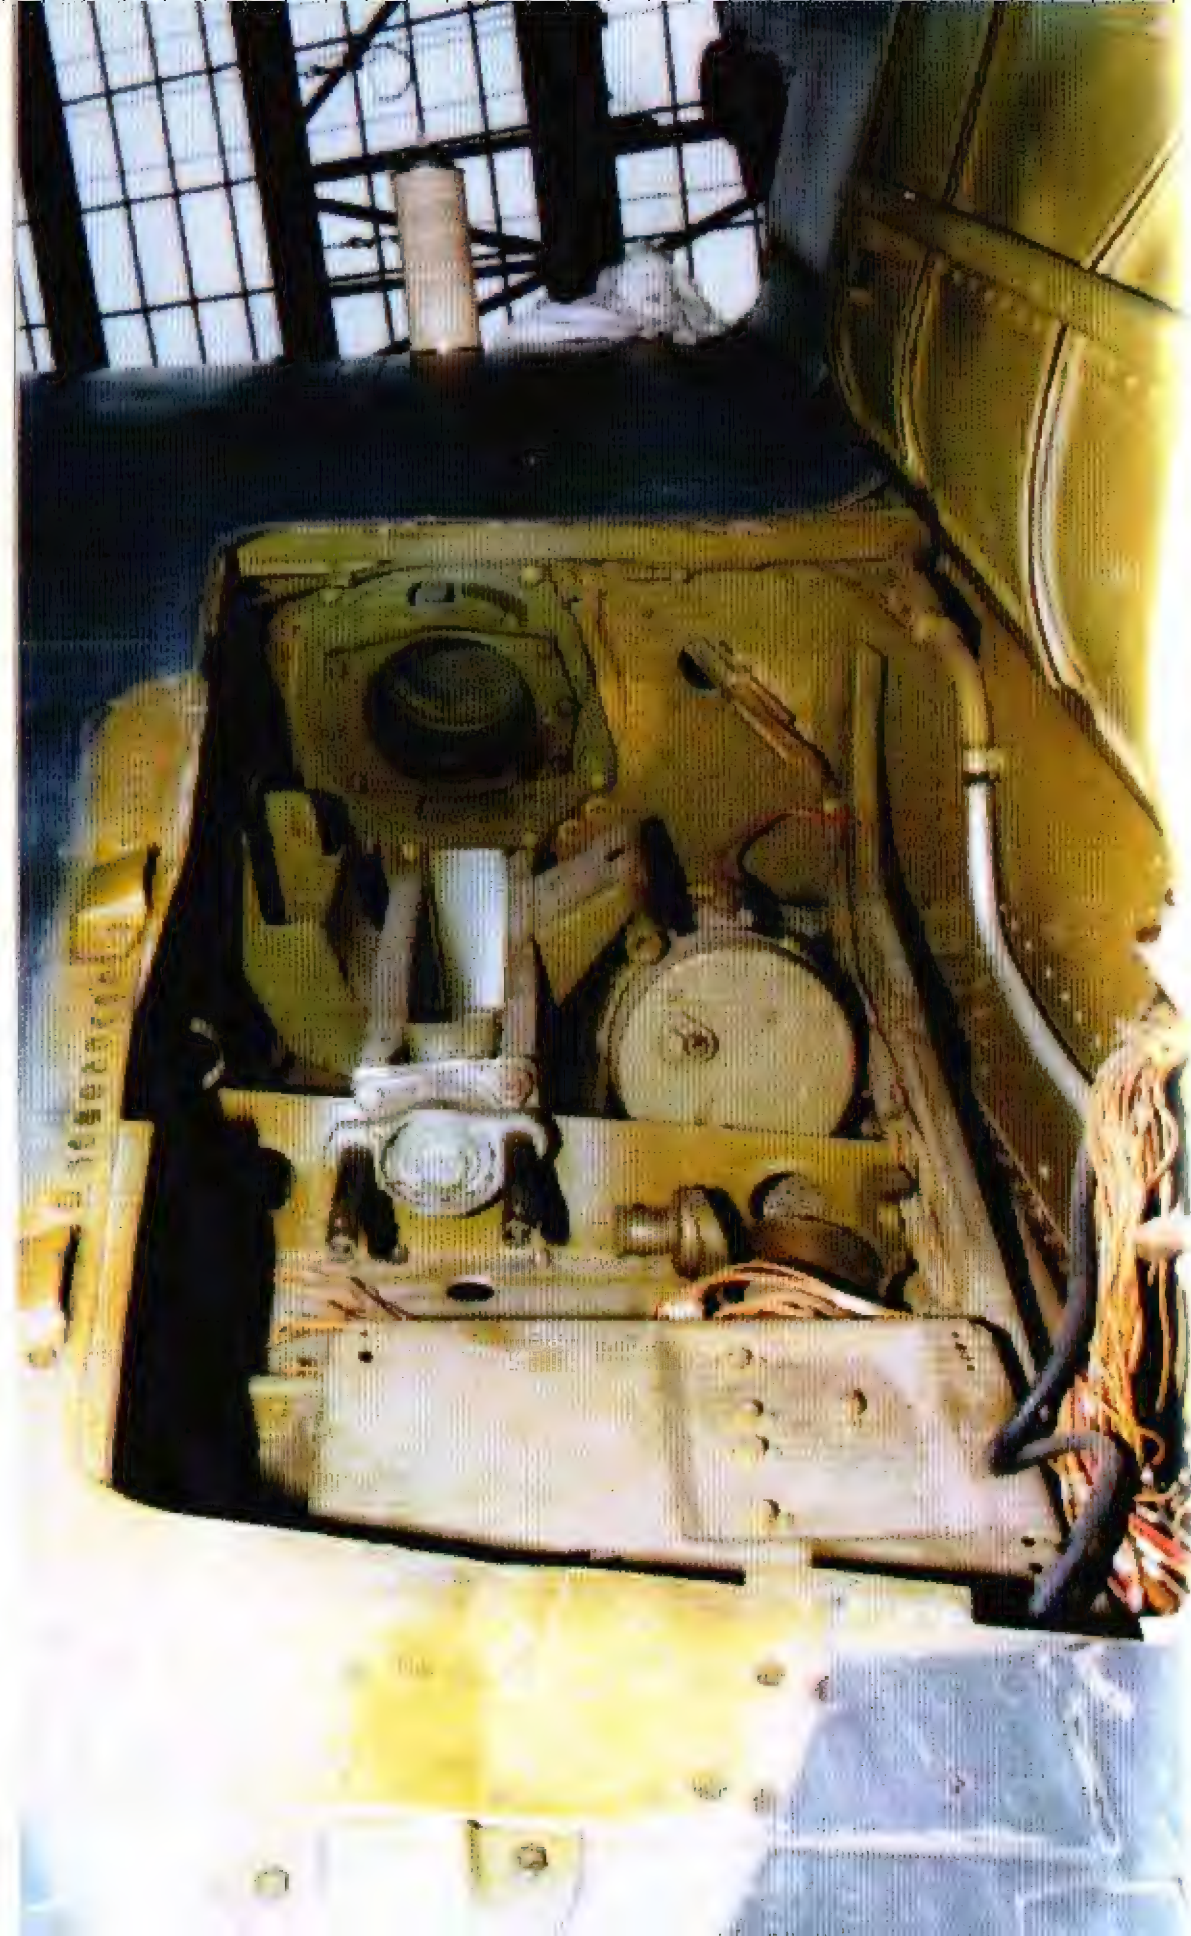
(Below and Right) The port wing root cannon access panel in the open position. The 20mm cannon is not installed affording a look at the various items under and around the MG 151. The wiring bundle coming out of the fuselage is part of the electrical system for cocking and firing the cannons. The gap at the front of the gun bay is for the 20mm ammunition and its feed chute. (Author: Ryle)

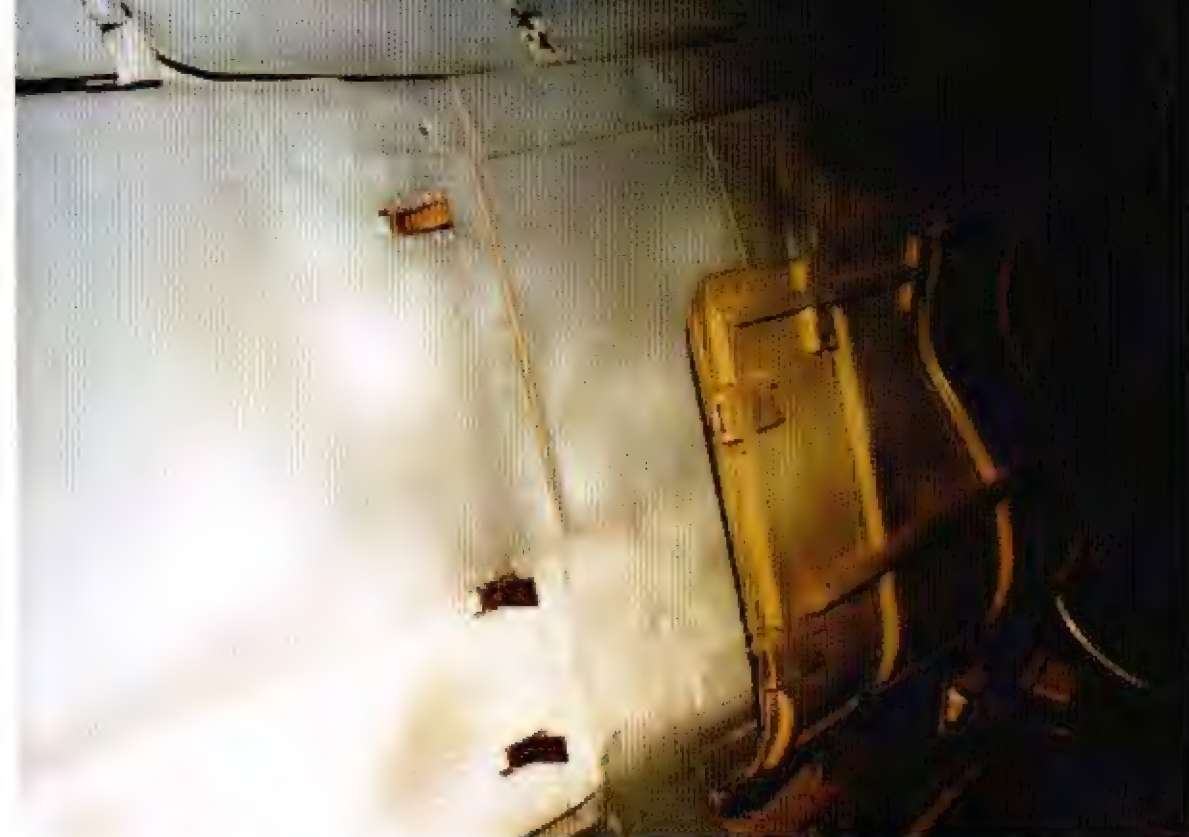
Just below the upper cowl gun panel the port cowl engine panel latches are in the open position. The hinged wing gun bay door is fully open. (J. Bishop)

The access panel was bulged to accommodate the MG 151 20mm cannon. The access panel is attached to the fuselage with nine small screws, the "piano" hinge may be seen just below the screws. (J. Bishop)

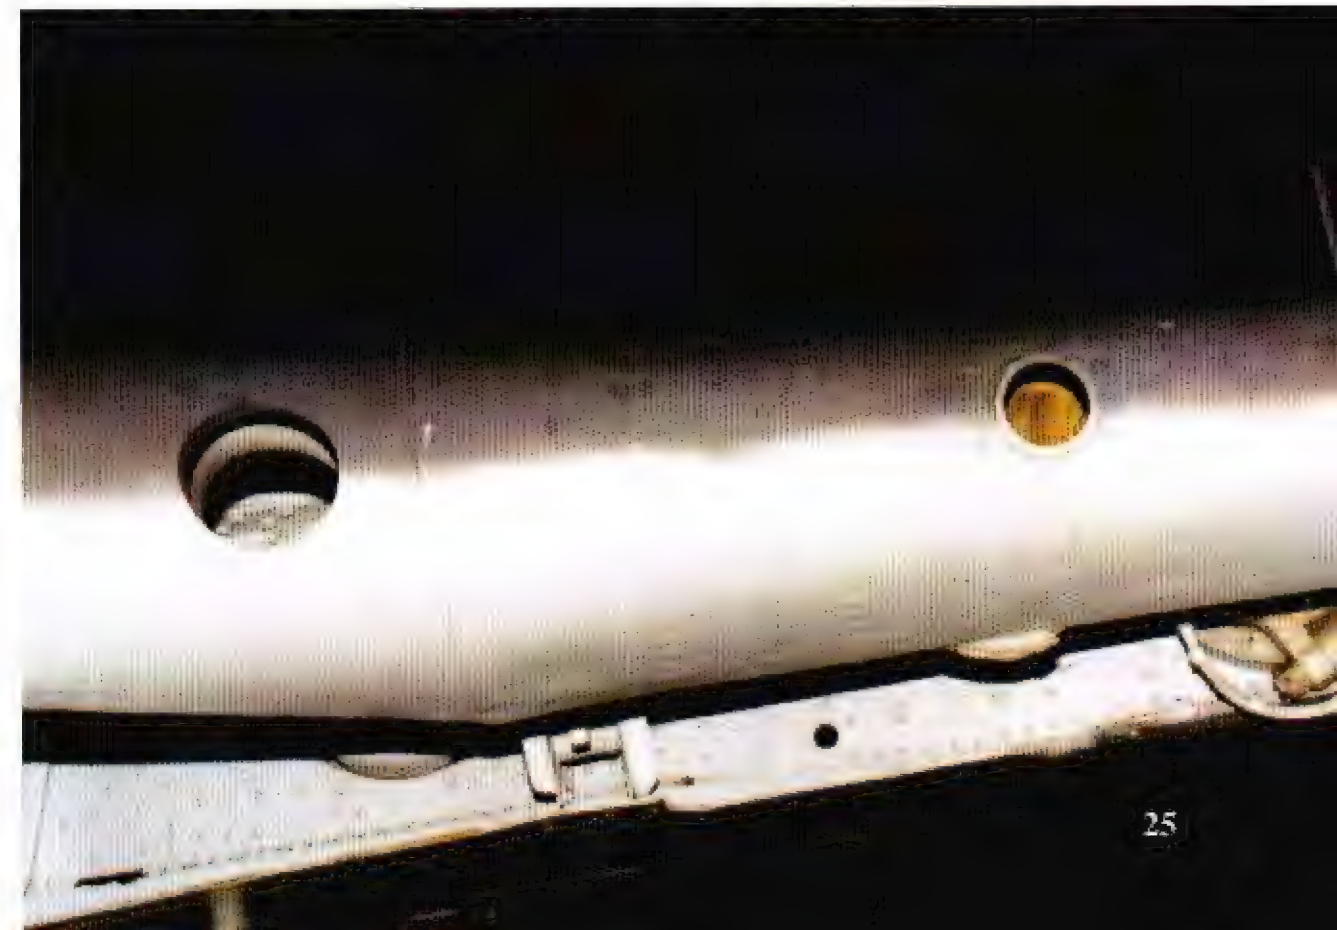
(Above and below) The port wing leading edge showing the empty wing root cannon port and the gun camera port. While the 20mm cannon port was produced as a part of the wing's leading edge panel, the camera port is a separate piece rivited into the leading edge of the wing panel. The glass cover on the camera port (missing) was exchangeable for a colored light filter. (D. Ryle)

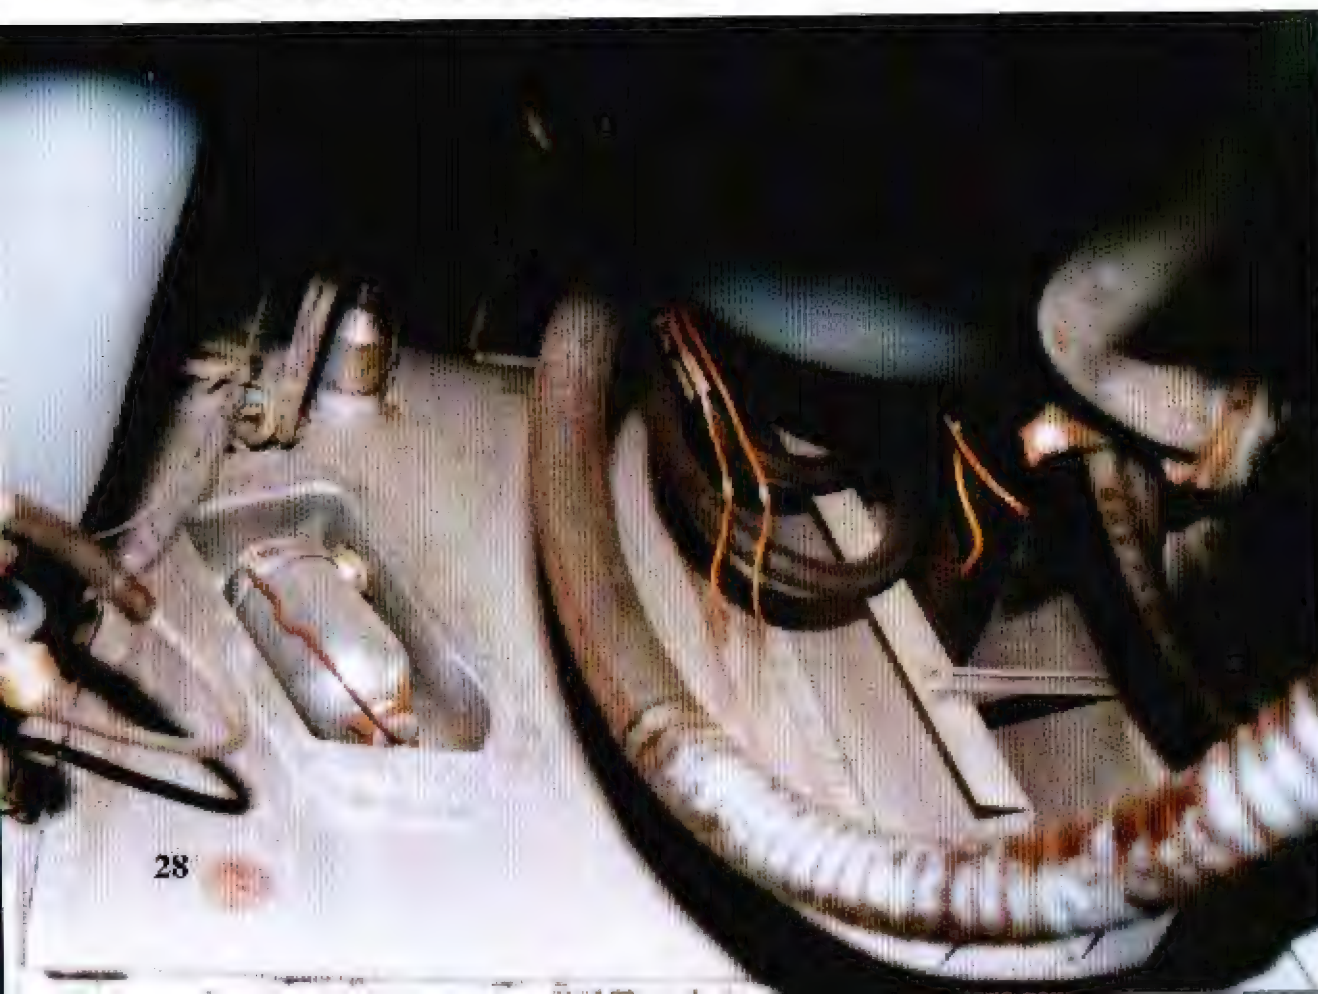
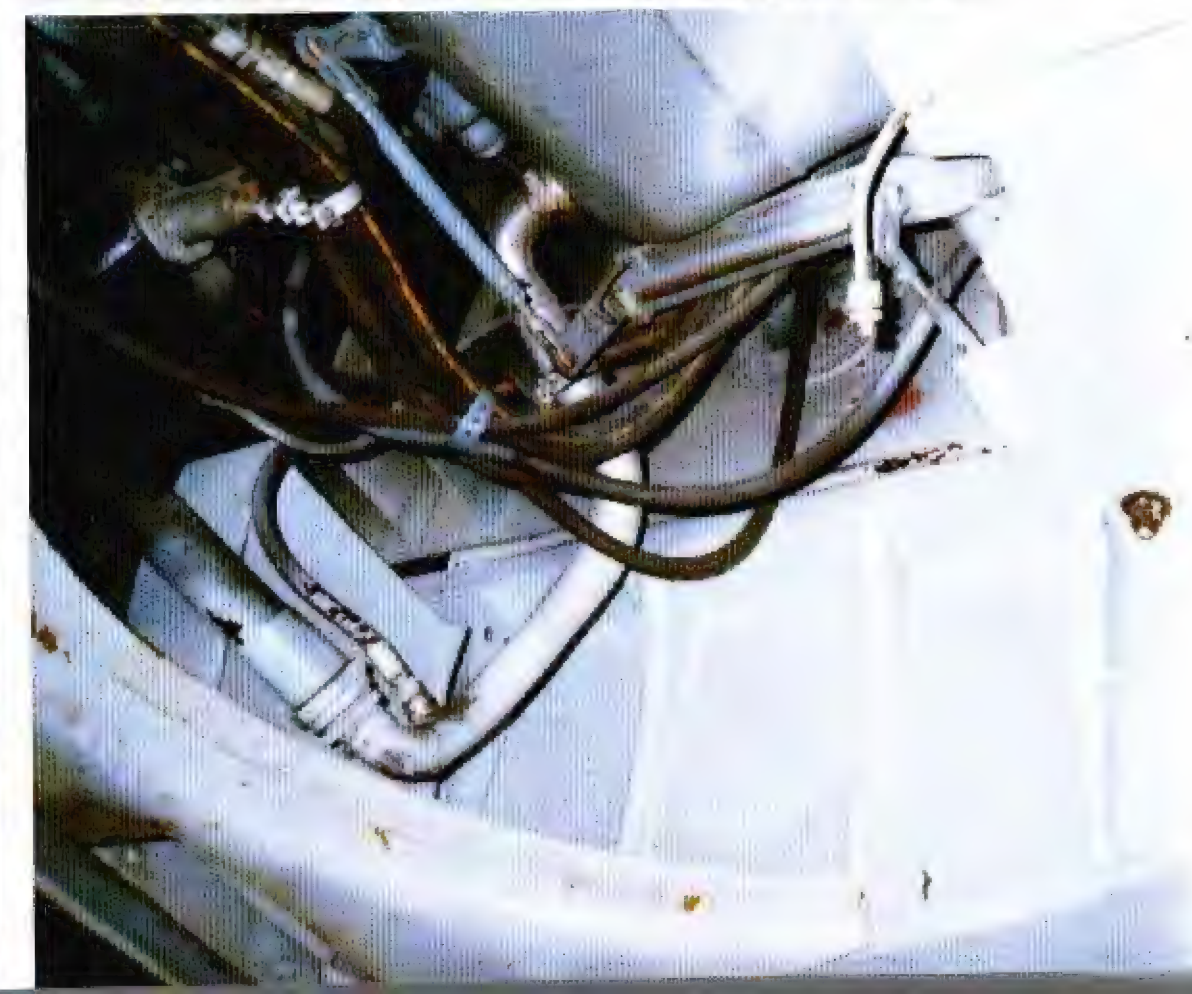
The port wheel well looking to the rear at the main wing spar, the throttle control linkages are at the top and the brass/link ejection port runs through the center of the wheel well exiting between the wheel wells. This configuration was designed for a center (engine) mounted cannon, which was not installed on the Fw 190D-9. (J. Bishop)

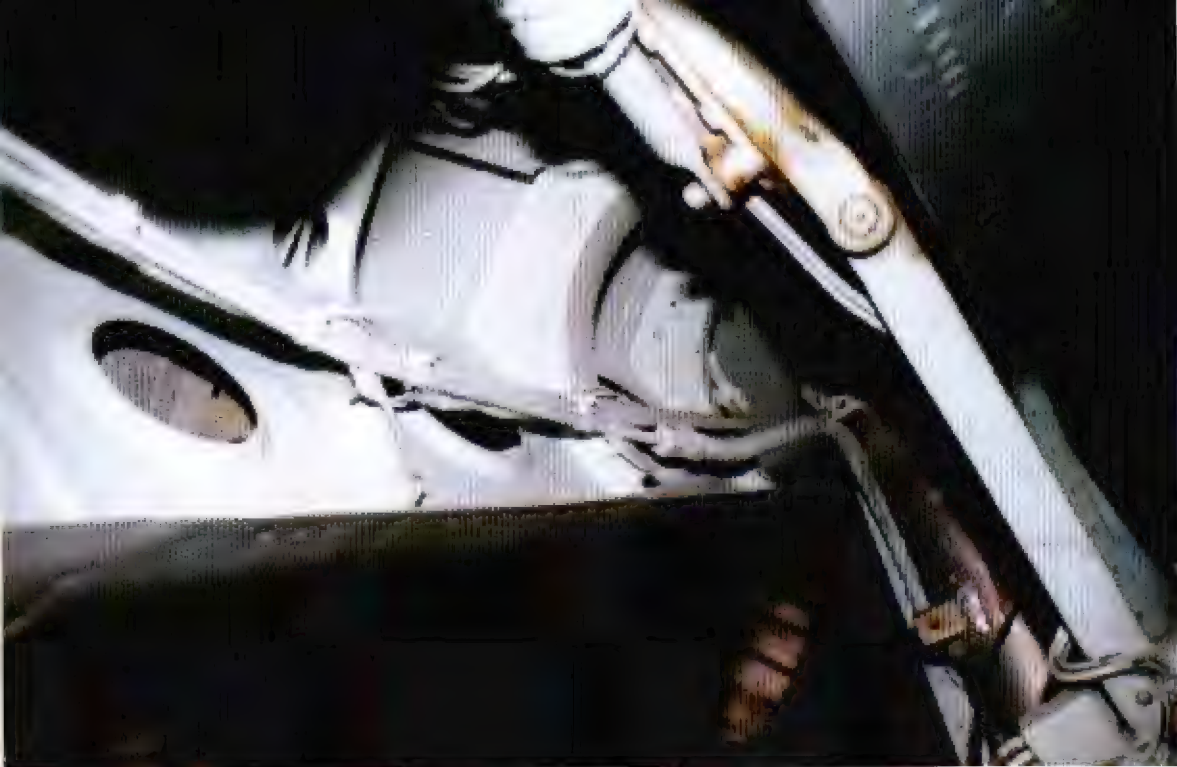
The starboard main wheel well contains a great deal of the lower engine plumbing. (J. Bishop)

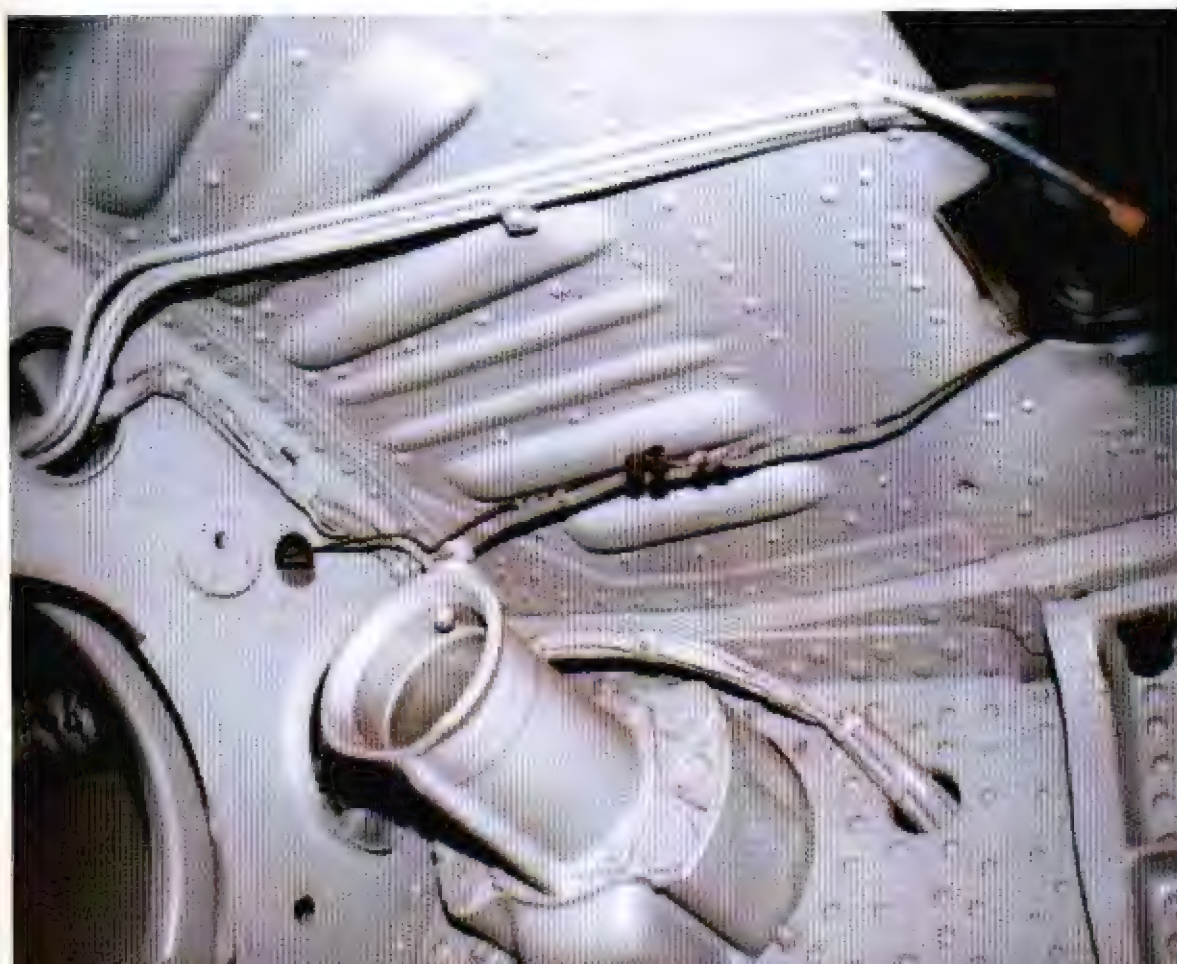
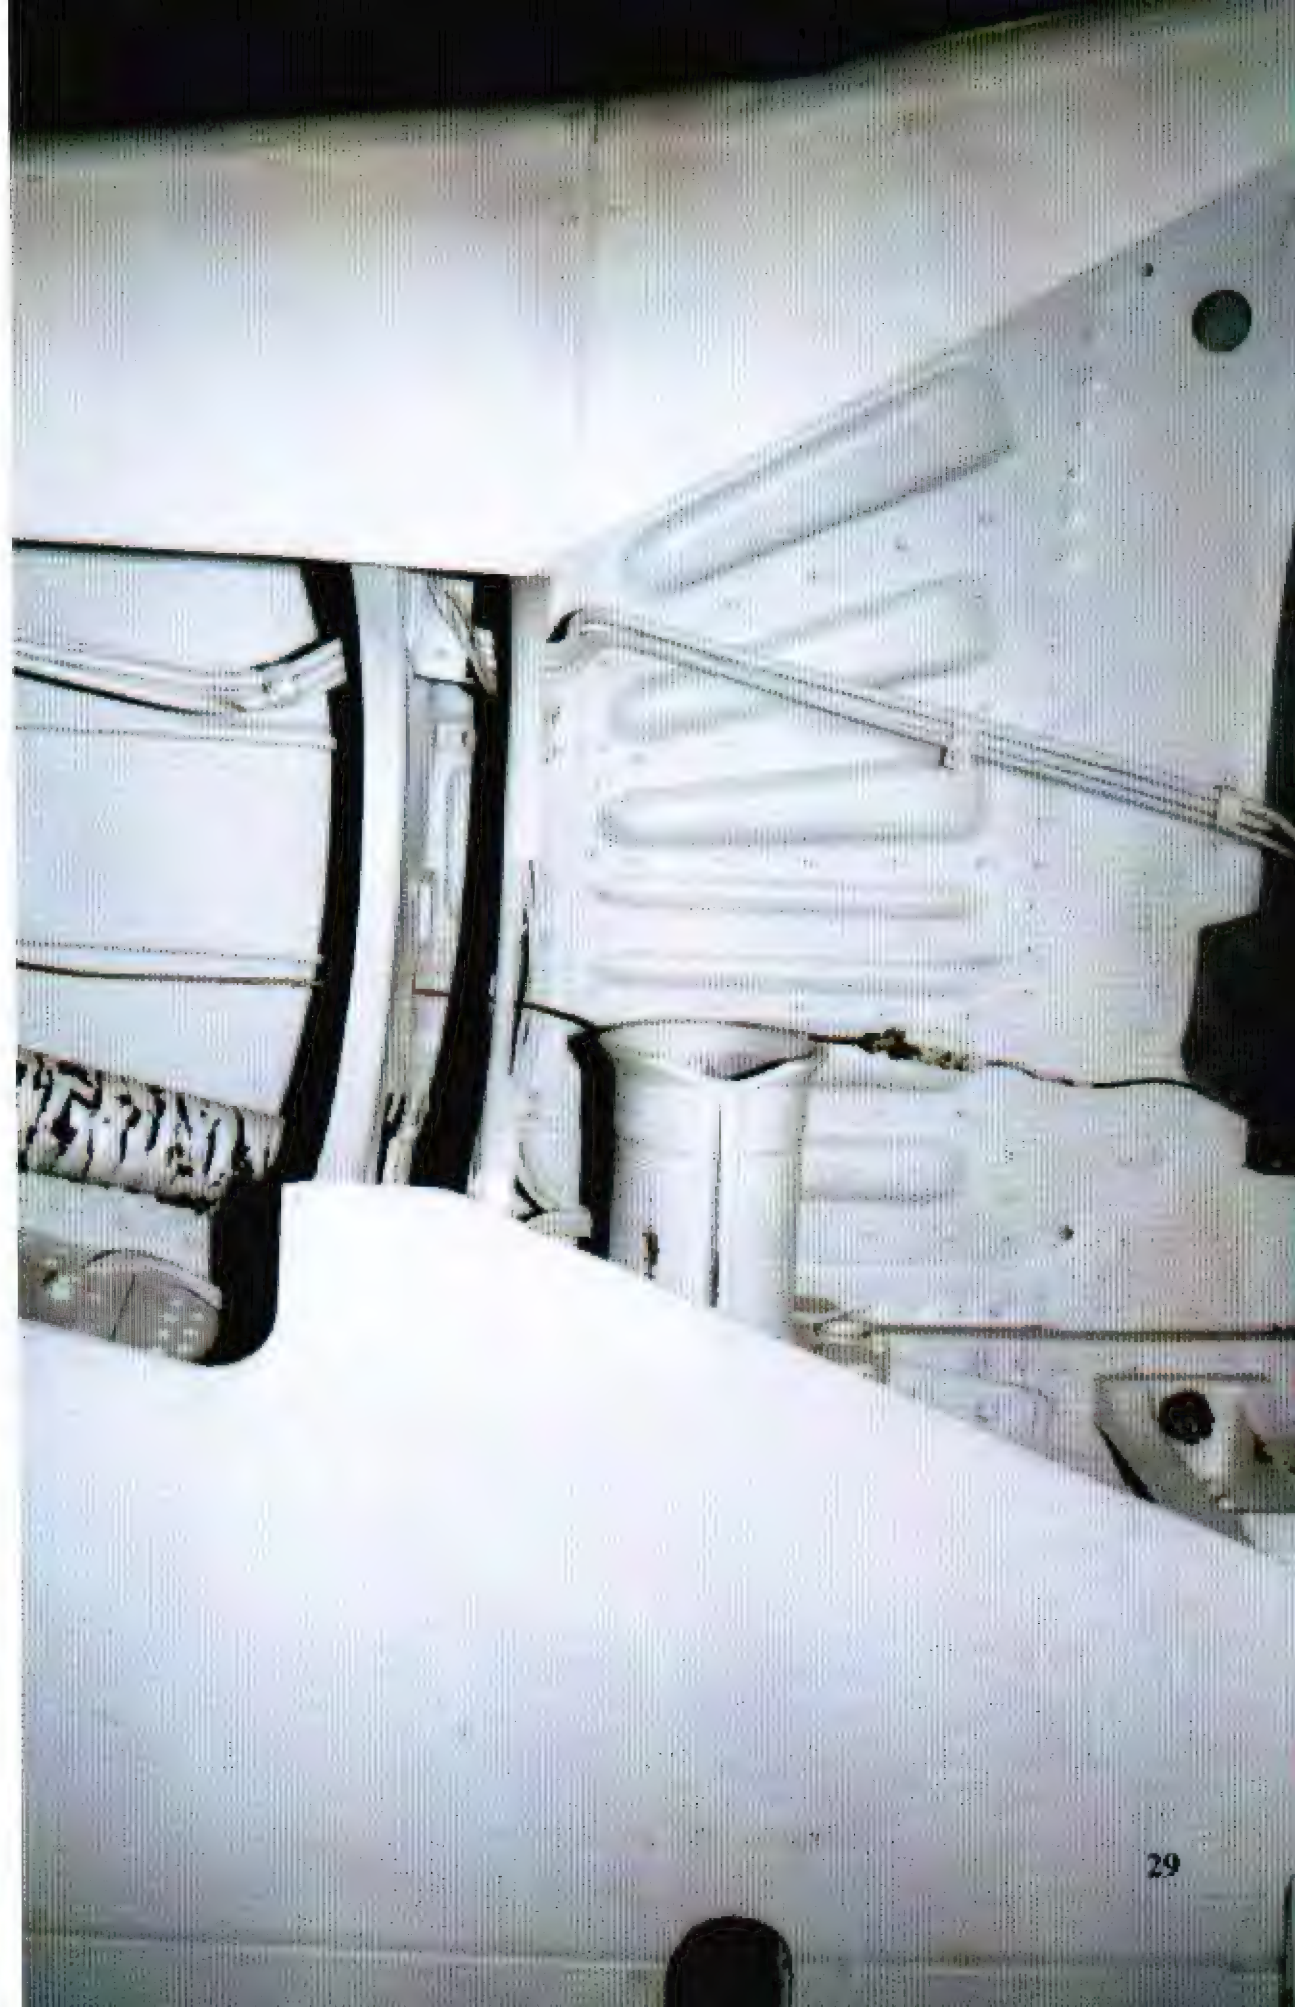
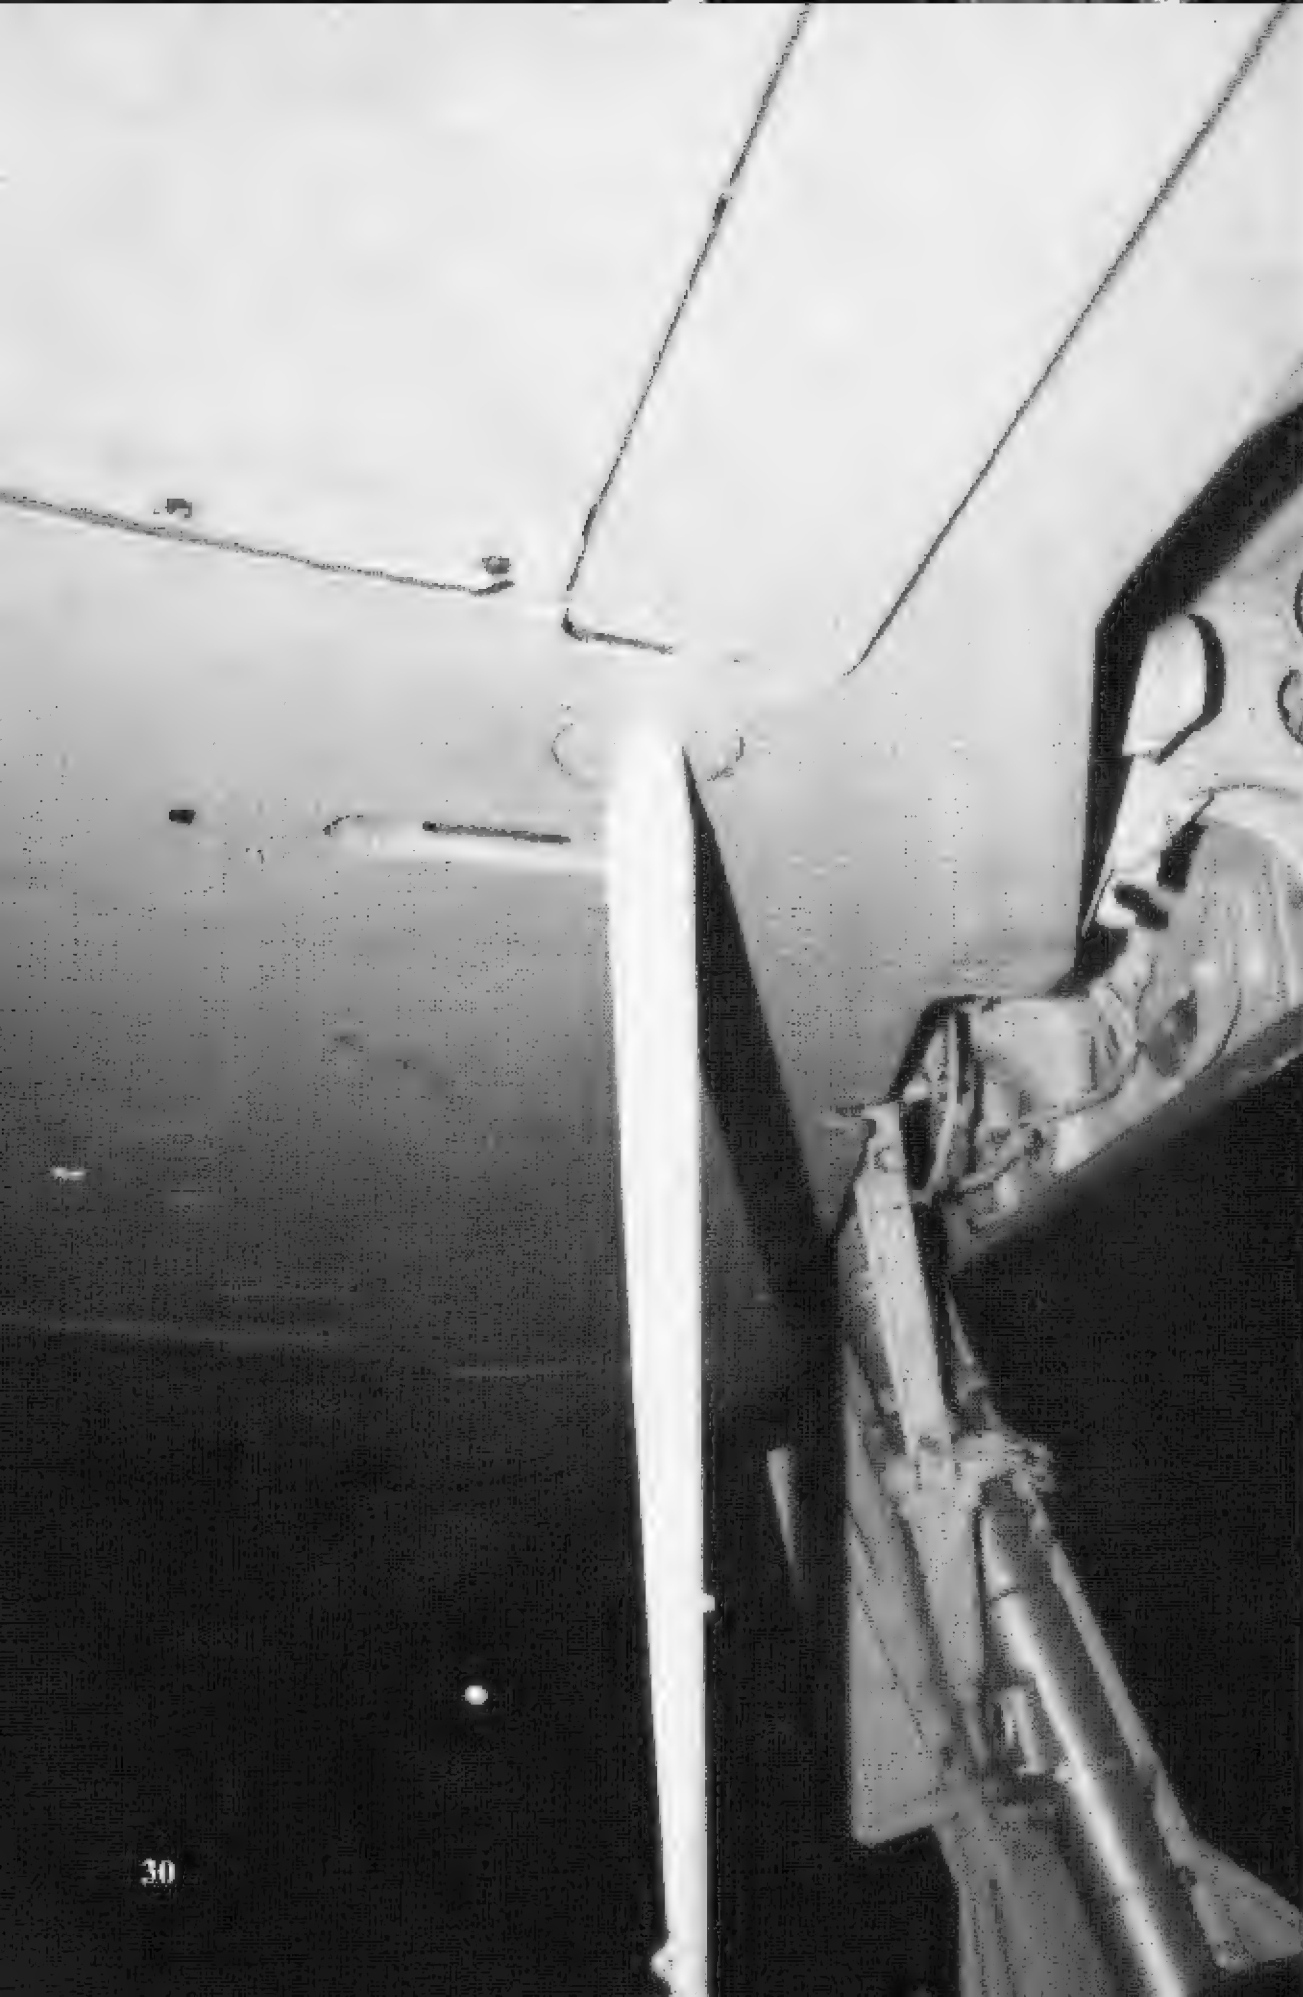
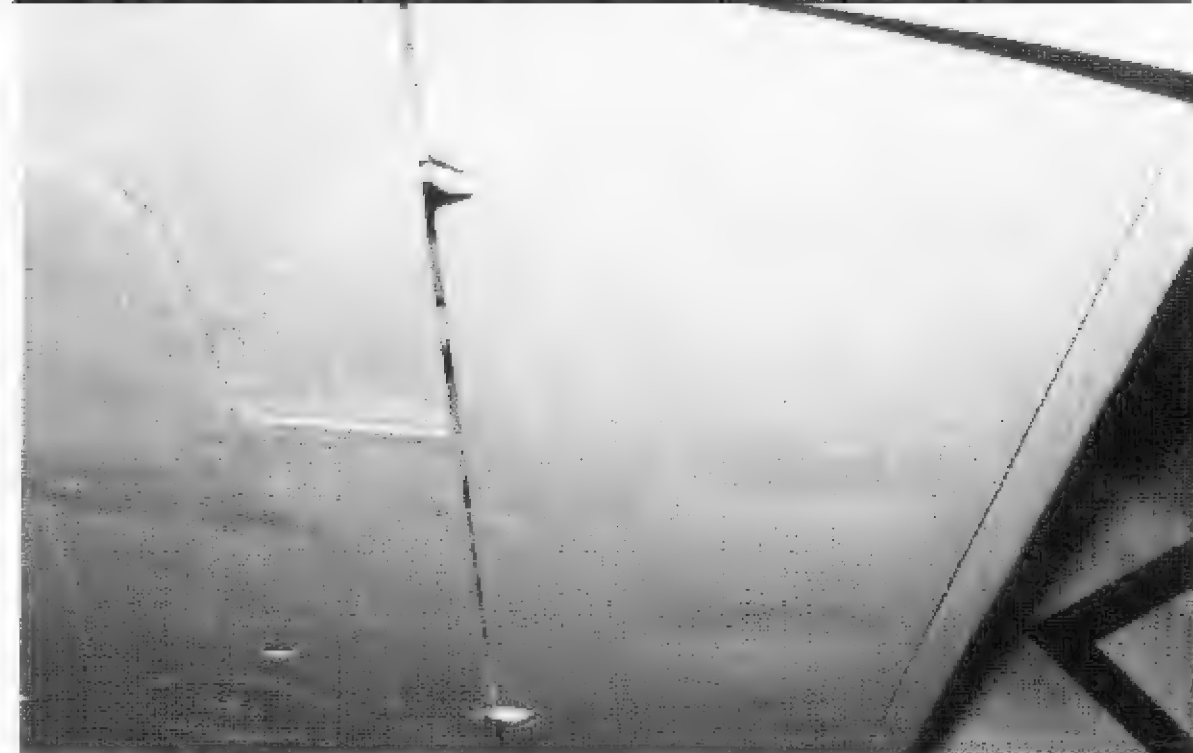
(Above) The construction of the starboard wheel well's forward wall with its electrical and brake lines are seen to advantage. (Author: Ryle)

(Right and below) The 20mm wing root gun mount coming out of the main spar. The pattern on the upper portion of the well are stiffeners stamped into the panel. A landing gear up-lock should be between the two braces outboard of the gun mount, but it is missing. (Author: Ryle)
